KENWOOD

ASB-1053

Service Bulletin

Subject: TS-950SDX Change of Gate Resistor Type **Date:** March 28, 1994

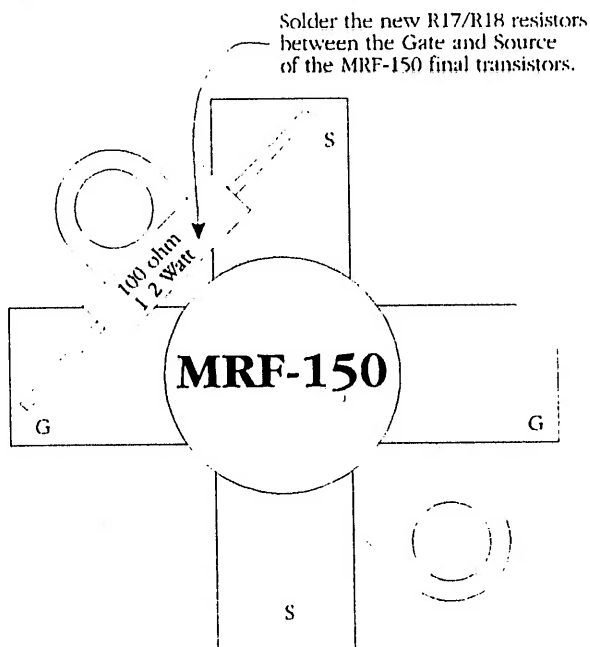
If the final amplifier is operated at excessive transmit levels (over 150 watts output) the final FET's may fail and short from Source to Gate. If this occurs, the bias resistors used in this circuit may be damaged and cause a large amount of smoke to be emitted from the final compartment.

Change the carbon type resistors used for R17 and R18 to the fuse type resistors specified below. This will prevent an unpleasant odor and smoke from the final compartment.

Remove the old resistors from their locations on the circuit board and install the new resistors directly between the Gate and Source of the final transistors. (See the illustration below.)
